# MEAT TRAIL

Living Museum of the West, Pipemakers Park  
Van Ness Avenue, Maribyrnong

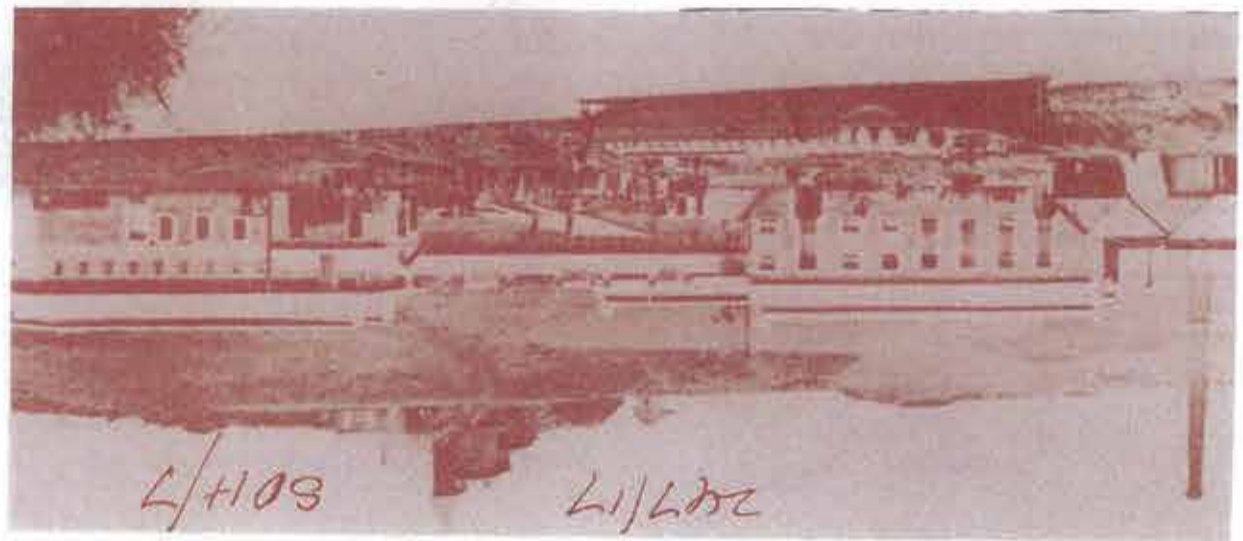
The Meatworks from the River c. 1870s.

The meat cannery probably had its preserving department in this area. An etching of 1868 gives an idea of what the factory looked like from the river. Alterations were made after a spectacular fire in 1873 and by the Hume Pipe Company in the 20th century, but the main bluestone building still standing is over 115 years old.

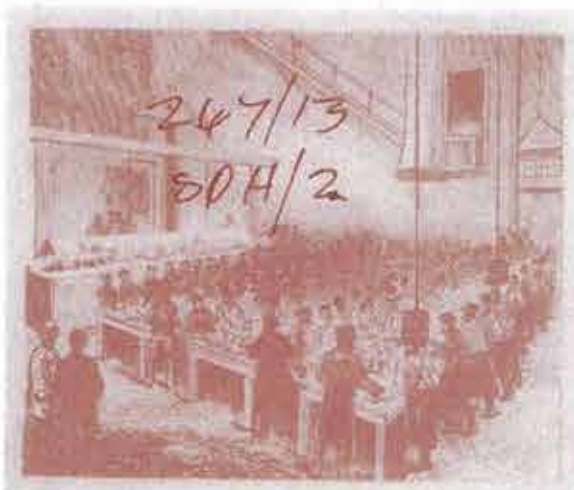
The Kitchen, Australasian Sketcher, 19.4.1873

A report from 1882 tells how the cans of meat were transferred from the kitchen by means of lifts and placed in the preserving pans suspended from a travelling crane. The cans were lowered into huge tanks heated by steam and then into cooling tanks. The process of cooling and sealing the meat involved great care and technology which was continually improving.

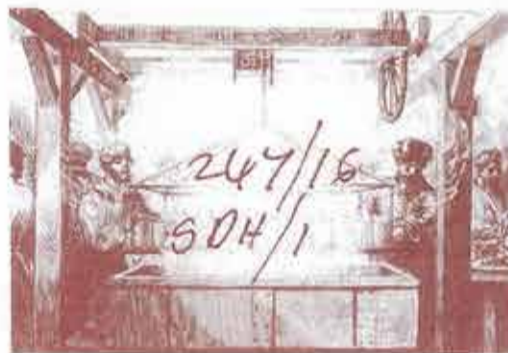
Preserving pan, Australasian Sketcher, 19.4.1873

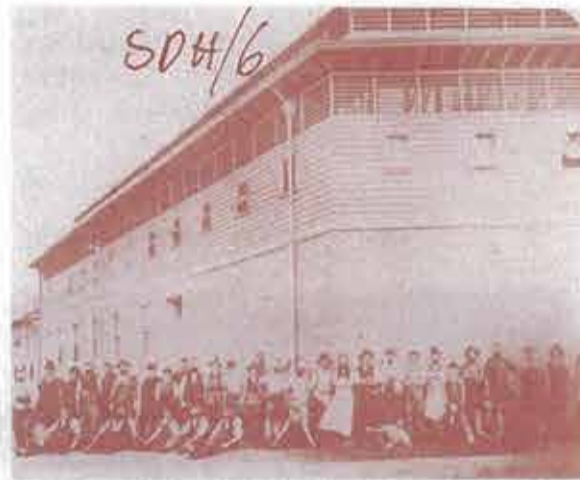
Meatworkers in the 1870s.

A photo of the meat-works employees outside this bluestone building in about 1875-80 gives an idea of the factory at that time. You can guess what the workers did by their dress. Butchers with aprons, tinsmiths with thick sacking around their waists, foremen or managers with coats and watches. This building dates from 1872 when the company extended its operations by adding a new tinsmiths' shop and machinery room to help meet the increased export demand.

Originally there was a second storey of timber with louvres in the top to ventilate the smoky tinshop. Notice the windows and doors in the photo. These match the bricked-up openings you can see in the wall.

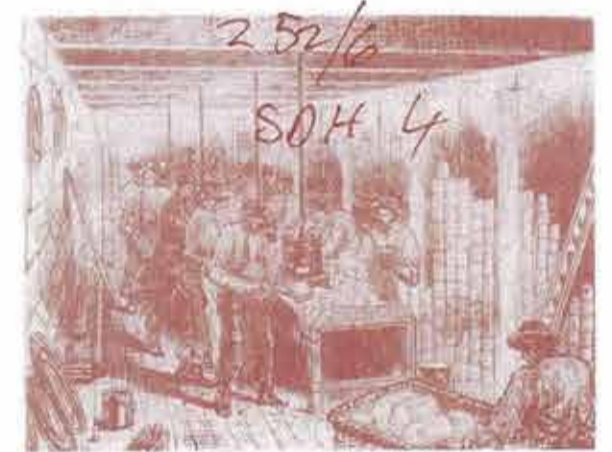
The Tinshop, Australasian Sketcher, 19.4.1873

Tinsmiths made the tins here from imported tin-plate (steel coated with tin). The lids, with a small hole left in them, were attached after the cans were filled with meat. After initial cooking, the holes were soldered as steam escaped from the can to ensure a good seal and to prevent contamination.
