**ARCHAEOLOGICAL
INVESTIGATIONS OF THE
CITY LINK DEVELOPMENT SITE
FOOTSCRAY 1989**

Andrew Wilson

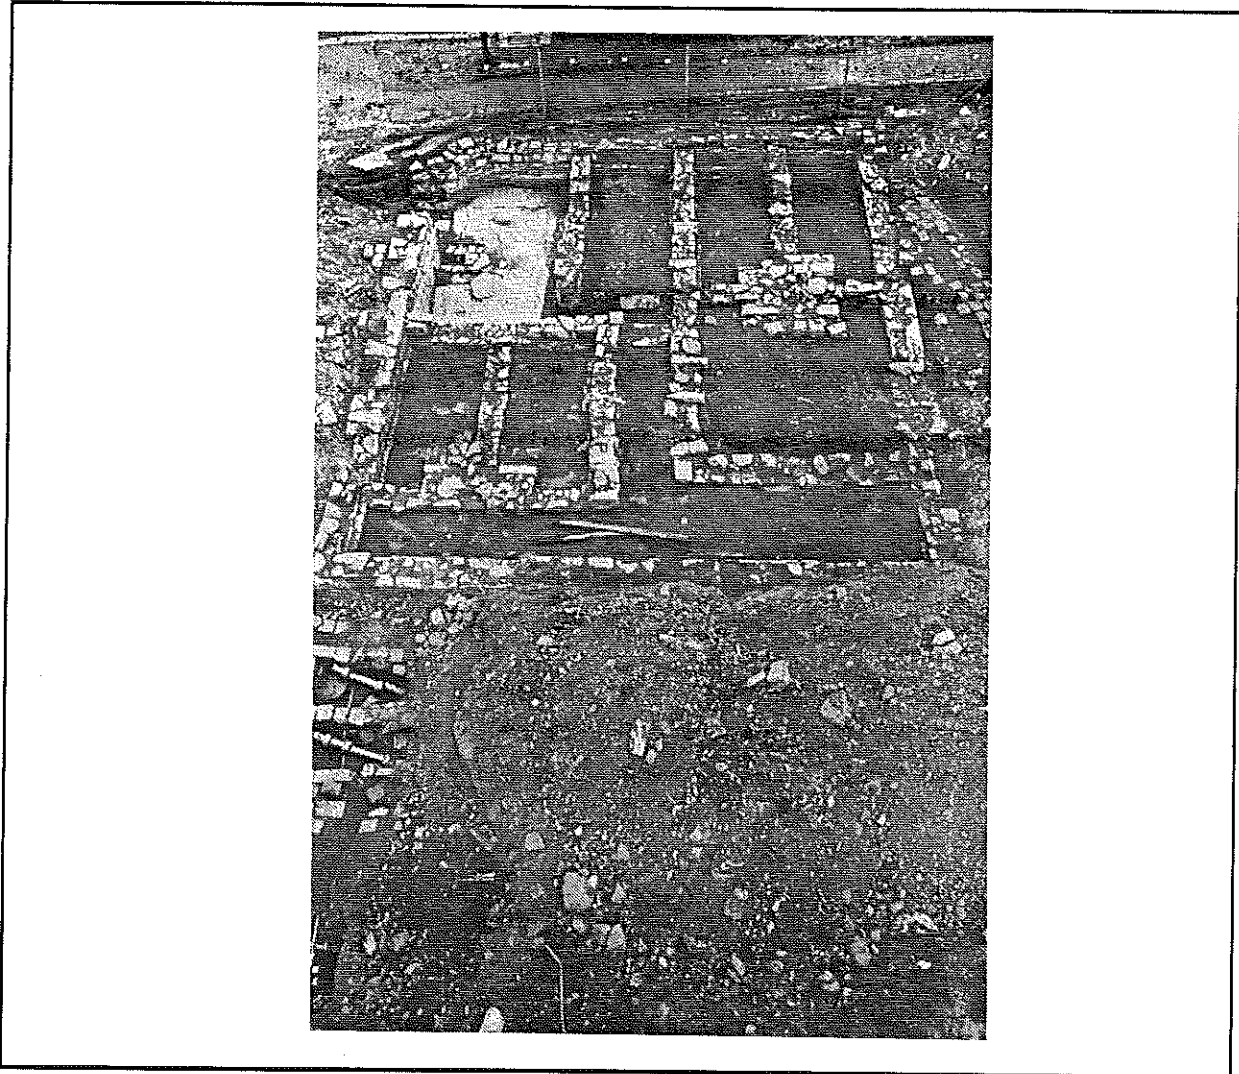
Figure 11

The Hotel was constructed using normal nineteenth century building techniques. The walls were built of brick on quarried bluestone foundations. Only the foundations and the shallow cellar survive. No part of the superstructure of the buildings survived its demolition in 1966. [See Figure 11]

Presumably the stone would have been procured from one of the quarries or stone finishing enterprises in the area. The foundations were formed using the normal 'rubble fill' method. Roughly shaped stones were used to define the outer edges of the foundation walls, using their flattest side as the external face. The hollow core of the wall and any gaps between the stones were then filled with small stone rubble packed in with large amounts of mortar.

While the techniques used were standard the manner in which construction proceeded was not. Rather than excavate to create the foundations and the cellar on a site that was already close to the level of the river and subject to flooding, the builders chose to begin construction of the eastern wall at the lowest point and then built in successive layers back up the slope. Apart from basic levelling, little excavation seems to have been undertaken for the cellar and foundations.

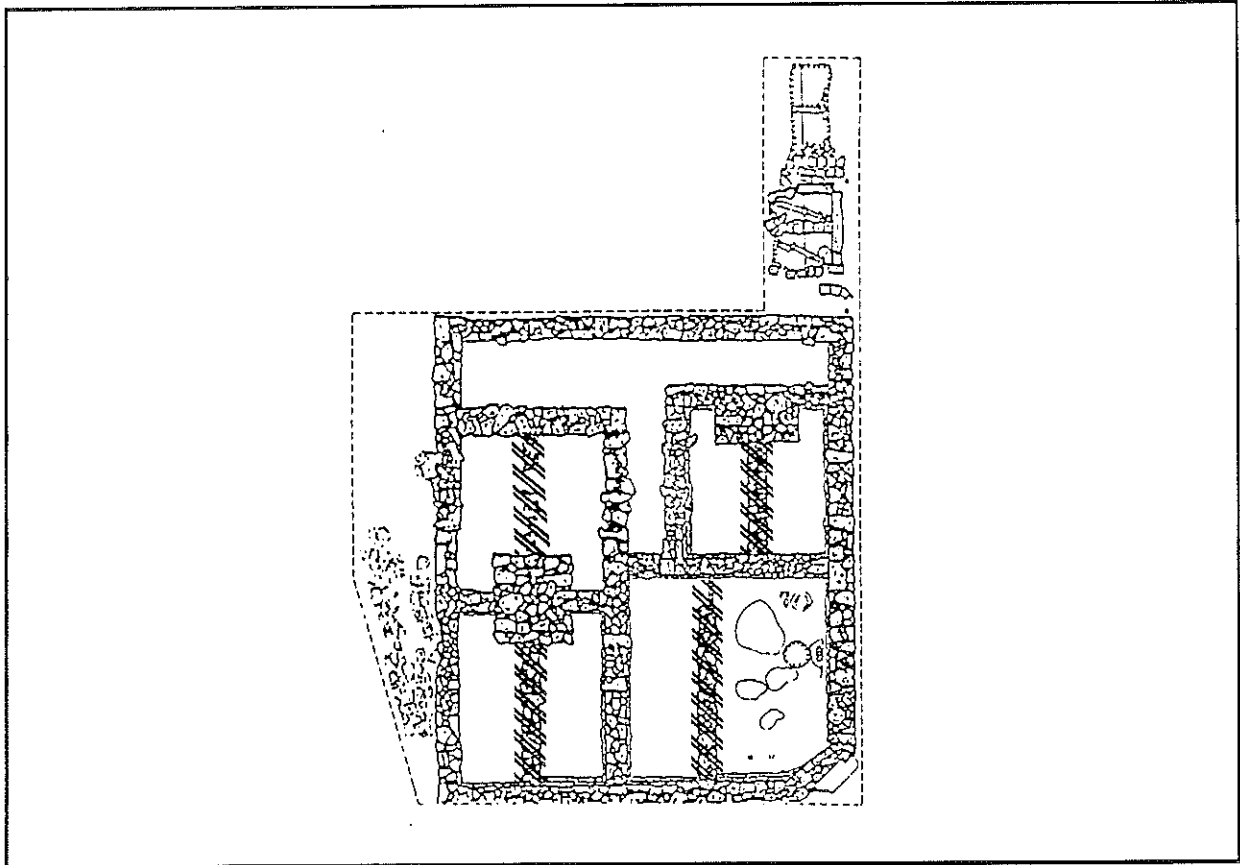
Figure 12

In addition to the foundations of the brick walls, 'sleeper walls' which supported the wooden floors (and therefore appear to divide the rooms in half at foundation level) were also constructed of stone. [See Figure 12]

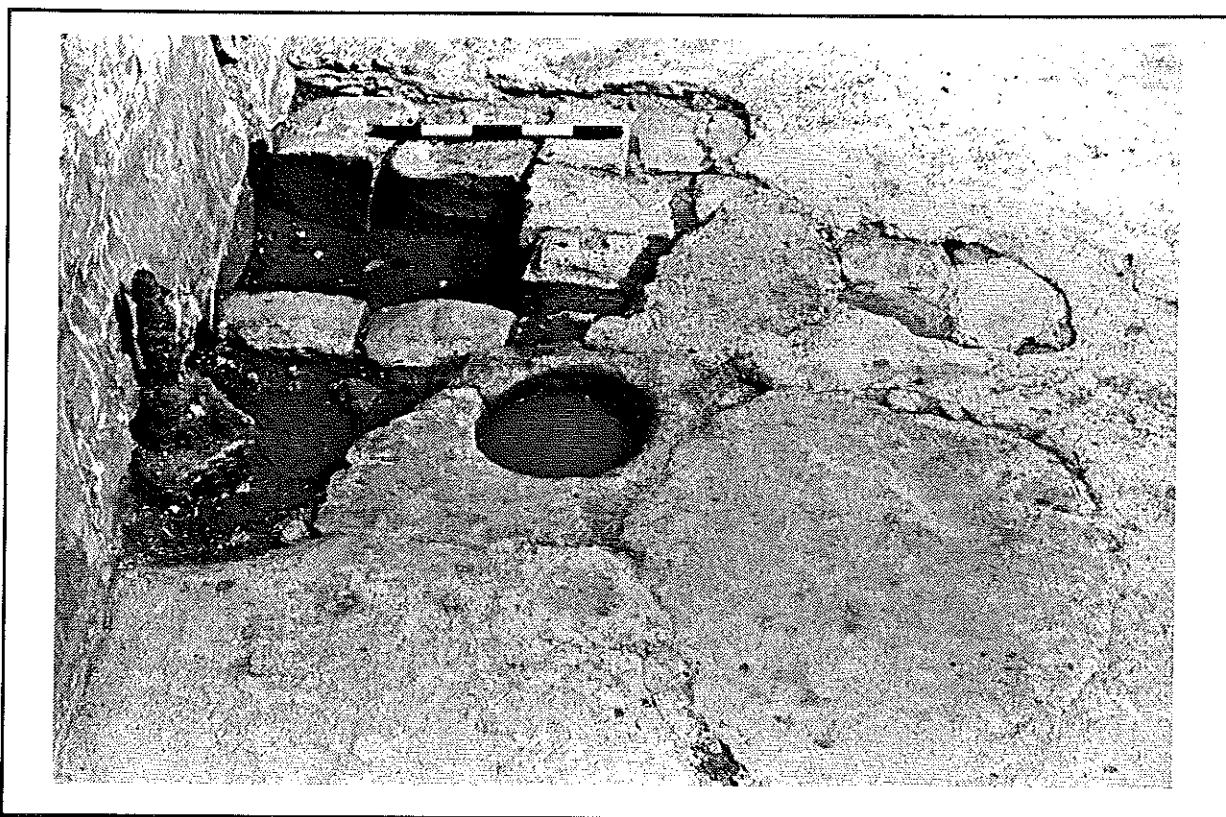
Figure 17

The circular sump, water connection and cement patches in the floor of the Bridge Hotel cellar. Part of the cement floor was removed during excavation to reveal the bluestone foundation below. Photograph Number M36.12 by Richard Moline. Scale in 100mm divisions

The constant use of the floor had worn it over the years and repairs had been required. Most of the original cement surface had been covered by a new layer, and the new surface was itself patched in places.²⁷ The walls of the cellar had been whitewashed.²⁸

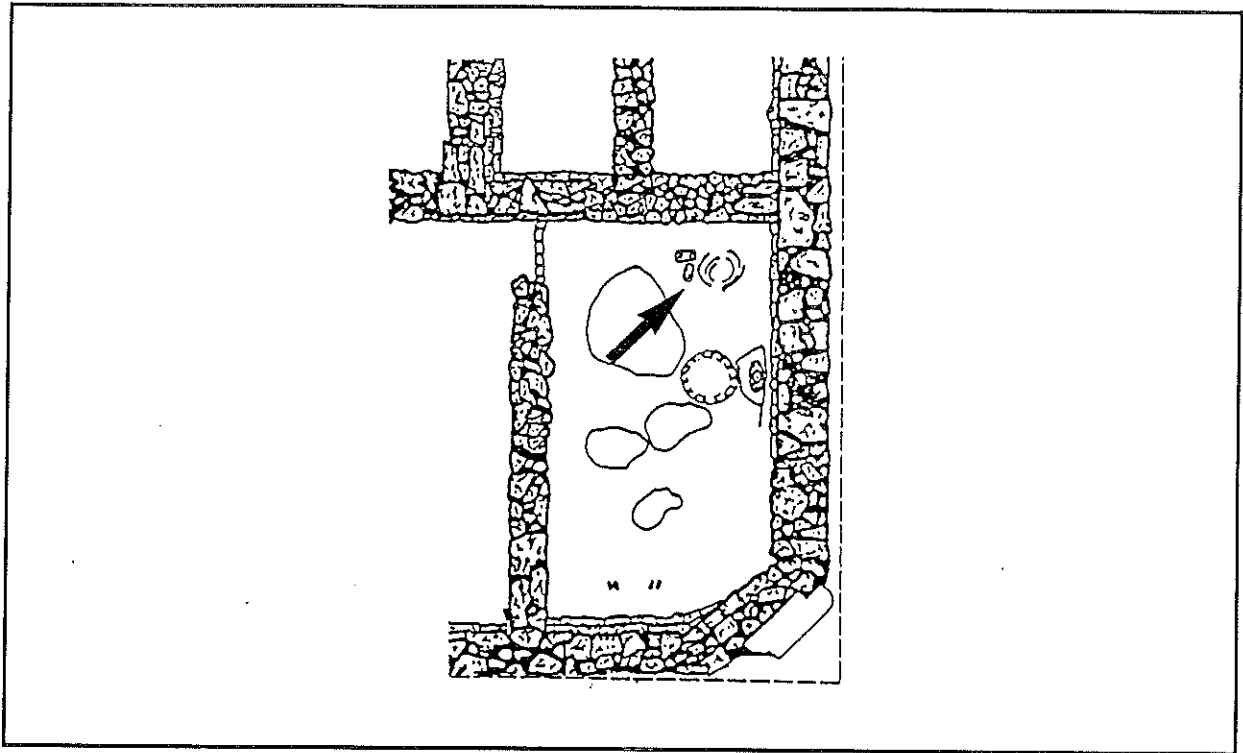
Figure 18

Despite the repair and renewal scars left by the moving of casks were clearly visible. At the southern end of the cellar indentations left by the ramp used to slide barrels into the cellar were found.²⁹ The delivery hatchway was below the easternmost window of the southern facade, so most, if not all of the draught beer dispensed in the pub over 76 years would have entered the building at this point. Most of the cellar area would have been taken up with storage, but at the northern end of the cellar floor a rectangular mortice in the cement indicated another activity area.³⁰ At this point the floor surface was marked with circular scratches, indicating that at this point the barrels had been turned on their ends to be hoisted through a hatch in the bar room floor and the mortice provided a seating for a prop or guide which assisted in this process. [See Figure 18]

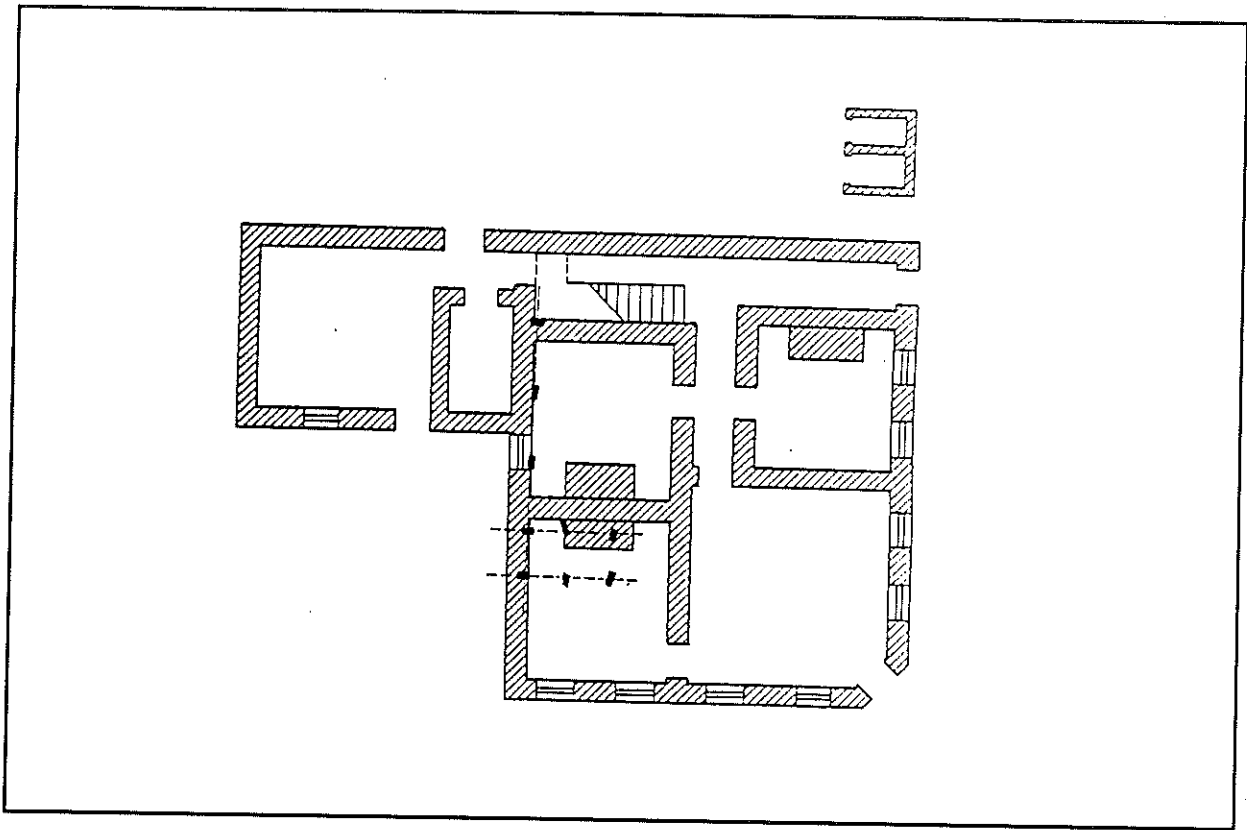
Figure 25

Plan of the Bridge Hotel with the locations of the sole plates from the later Tin Shed superimposed. The Plates were set out on a grid, indicated by the broken lines. Scale 1:200

Immediately after the demolition of the building the site was levelled and a galvanised iron shed erected on the site. The shed was on a wooden frame which rested on wooden sole plates set directly into the hard dry rubble deposits which resulted from the demolition and formed an ideal base. Nine of these small wooden plates, each 300mm long by 150mm wide and 38mm thick were found in place over the western part of the site.³⁶ [See Figure 25] They are the only evidence of the building which replaced the Bridge Hotel and provided the reason for its destruction.

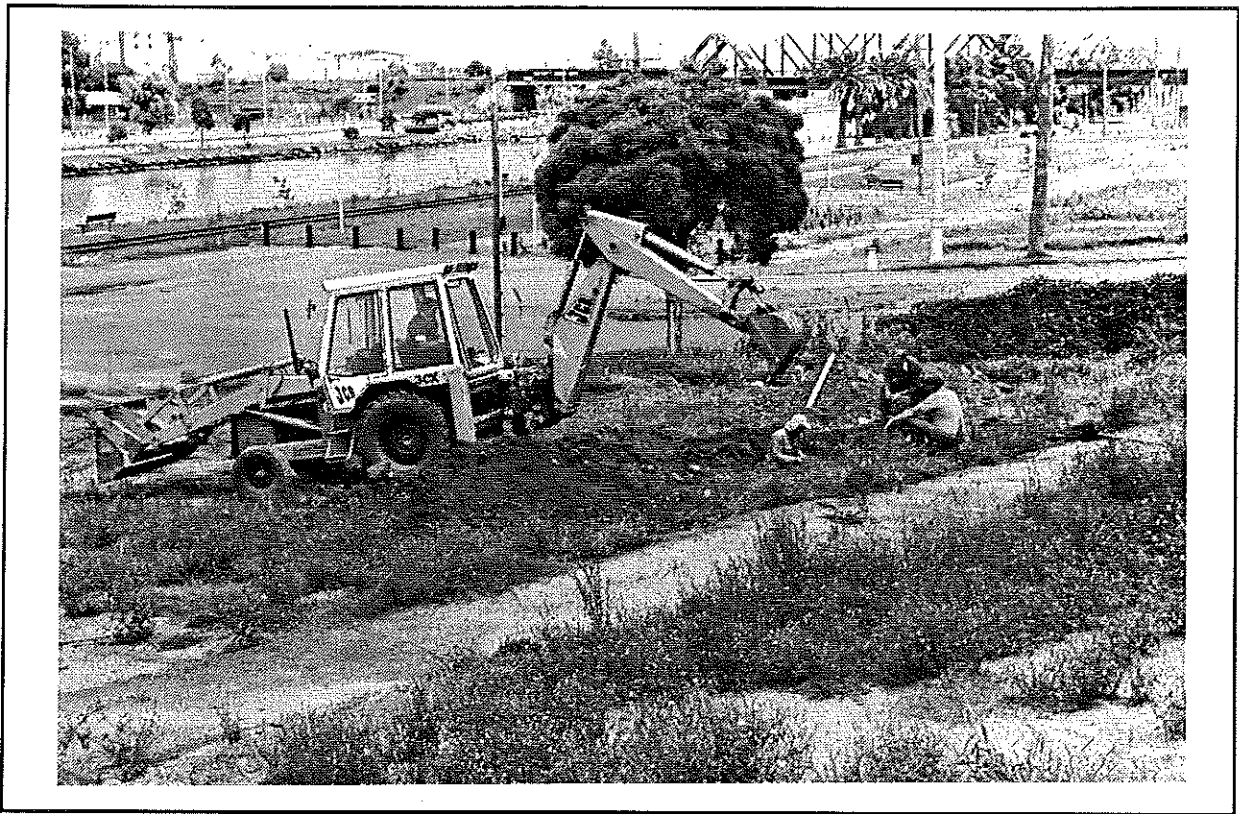
Figure 26

The site of the Bridge Hotel at the beginning of the excavation. Mechanical excavators were used to remove the recent overburden. The machine operator should be supervised and guided by archaeologists at all times to avoid damage to the remains. Photograph Number Mo1.11 by Richard Moline.

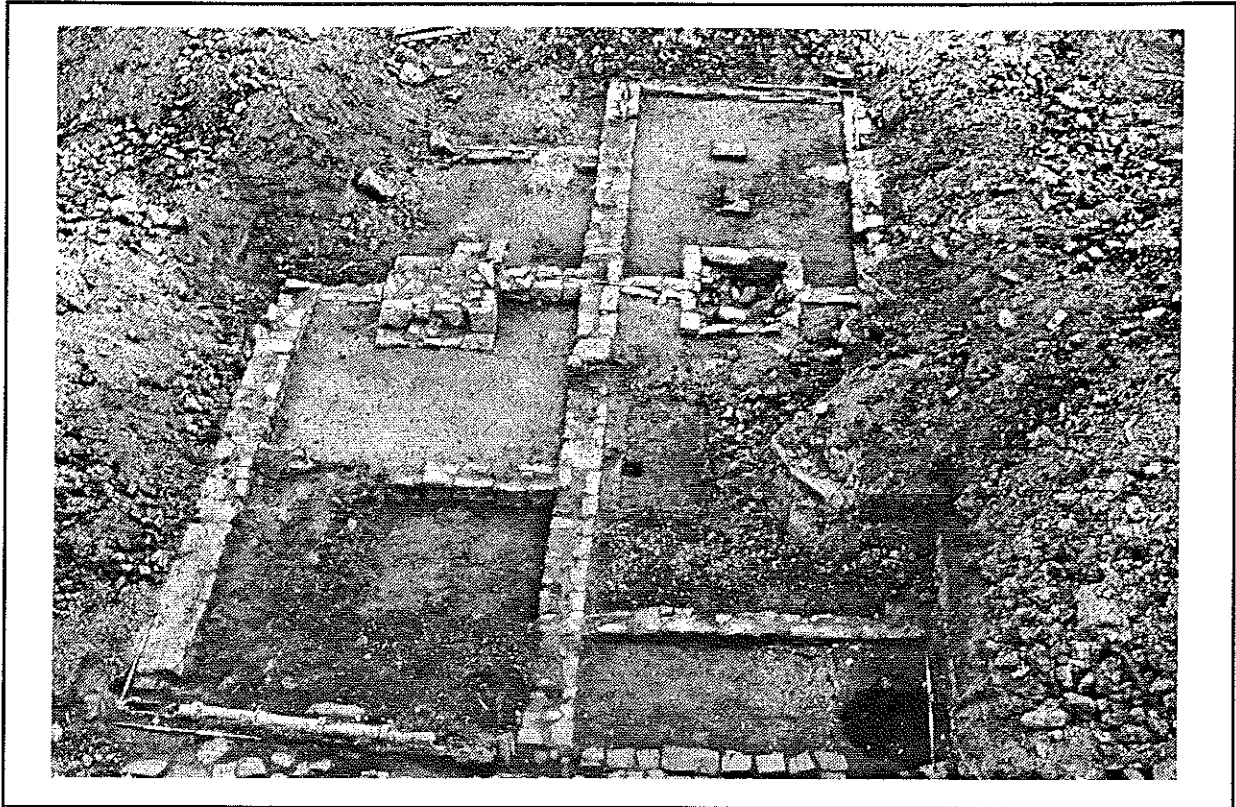
Figure 30

The cottages were constructed using standard nineteenth century building techniques. The walls were built of brick on quarried bluestone foundations. Only these foundations survive. No part of the superstructure of the cottages survived the demolition. [See Figure 30]

As with other buildings in the area, the stone most probably came from one of the local quarries or stone finishing enterprises. The foundations were formed using the normal 'rubble fill' method. Roughly shaped stones were used to define the outer edges of the foundation walls, using their flattest side as the external face, the hollow core of the wall and any gaps between the stones were then filled with small stone rubble packed in mortar.

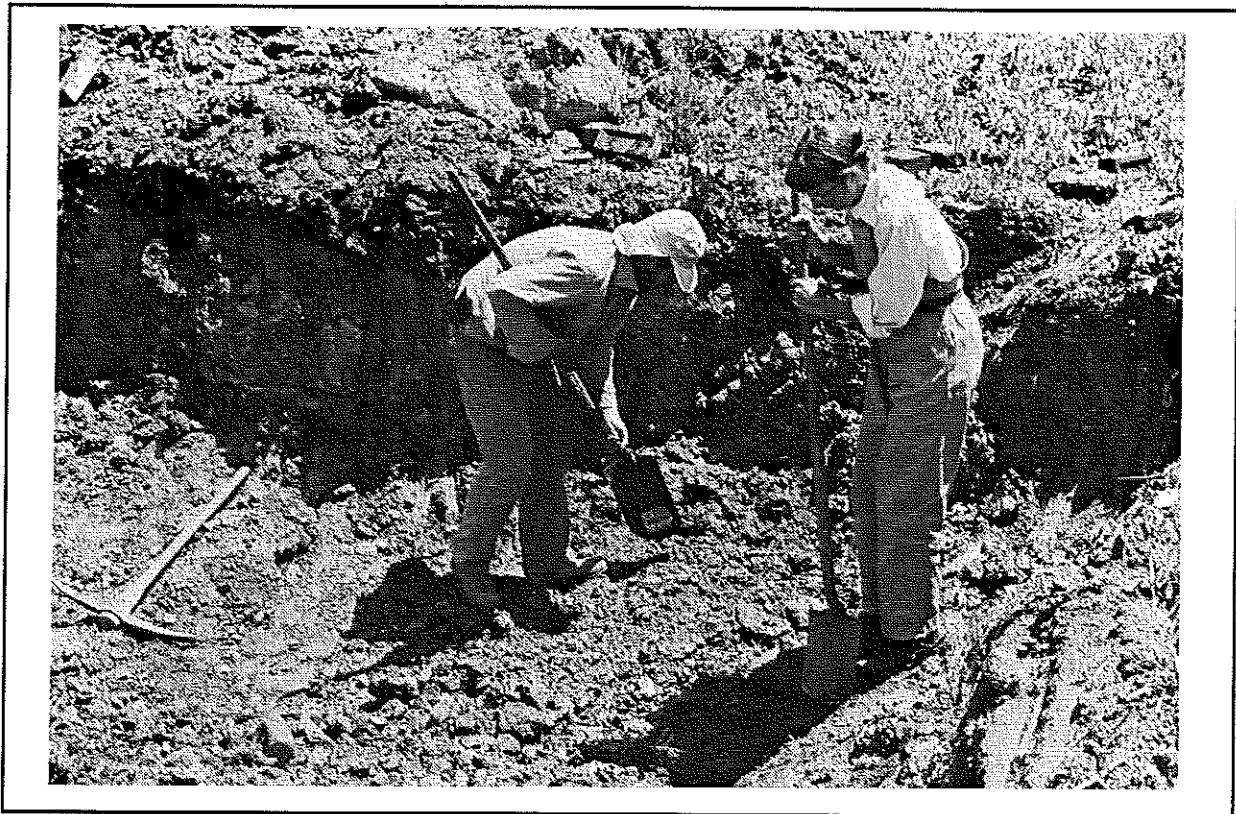
Figure 39

David Bannear and Robyn Annear clearing the site of the Pickett Cottages in the initial stages of excavation. More than a metre of recent fill covered most of the site. Photograph Number M01.35 by Richard Moline

Finally, recent fill deposits were used to bring the site up to its present level.⁵⁶ [See Figure 39] The presence of late nineteenth century artefacts in these deposits do not indicate that the deposits are of this date. The levelling and filling deposits result in part from the disturbance of earlier deposits on the site, and the introduction of fills from elsewhere. Therefore the artefacts they contain do not provide us with the date of deposition (or redeposition) on the site, but rather indicate their original date of creation which is independent of their presence on the site.

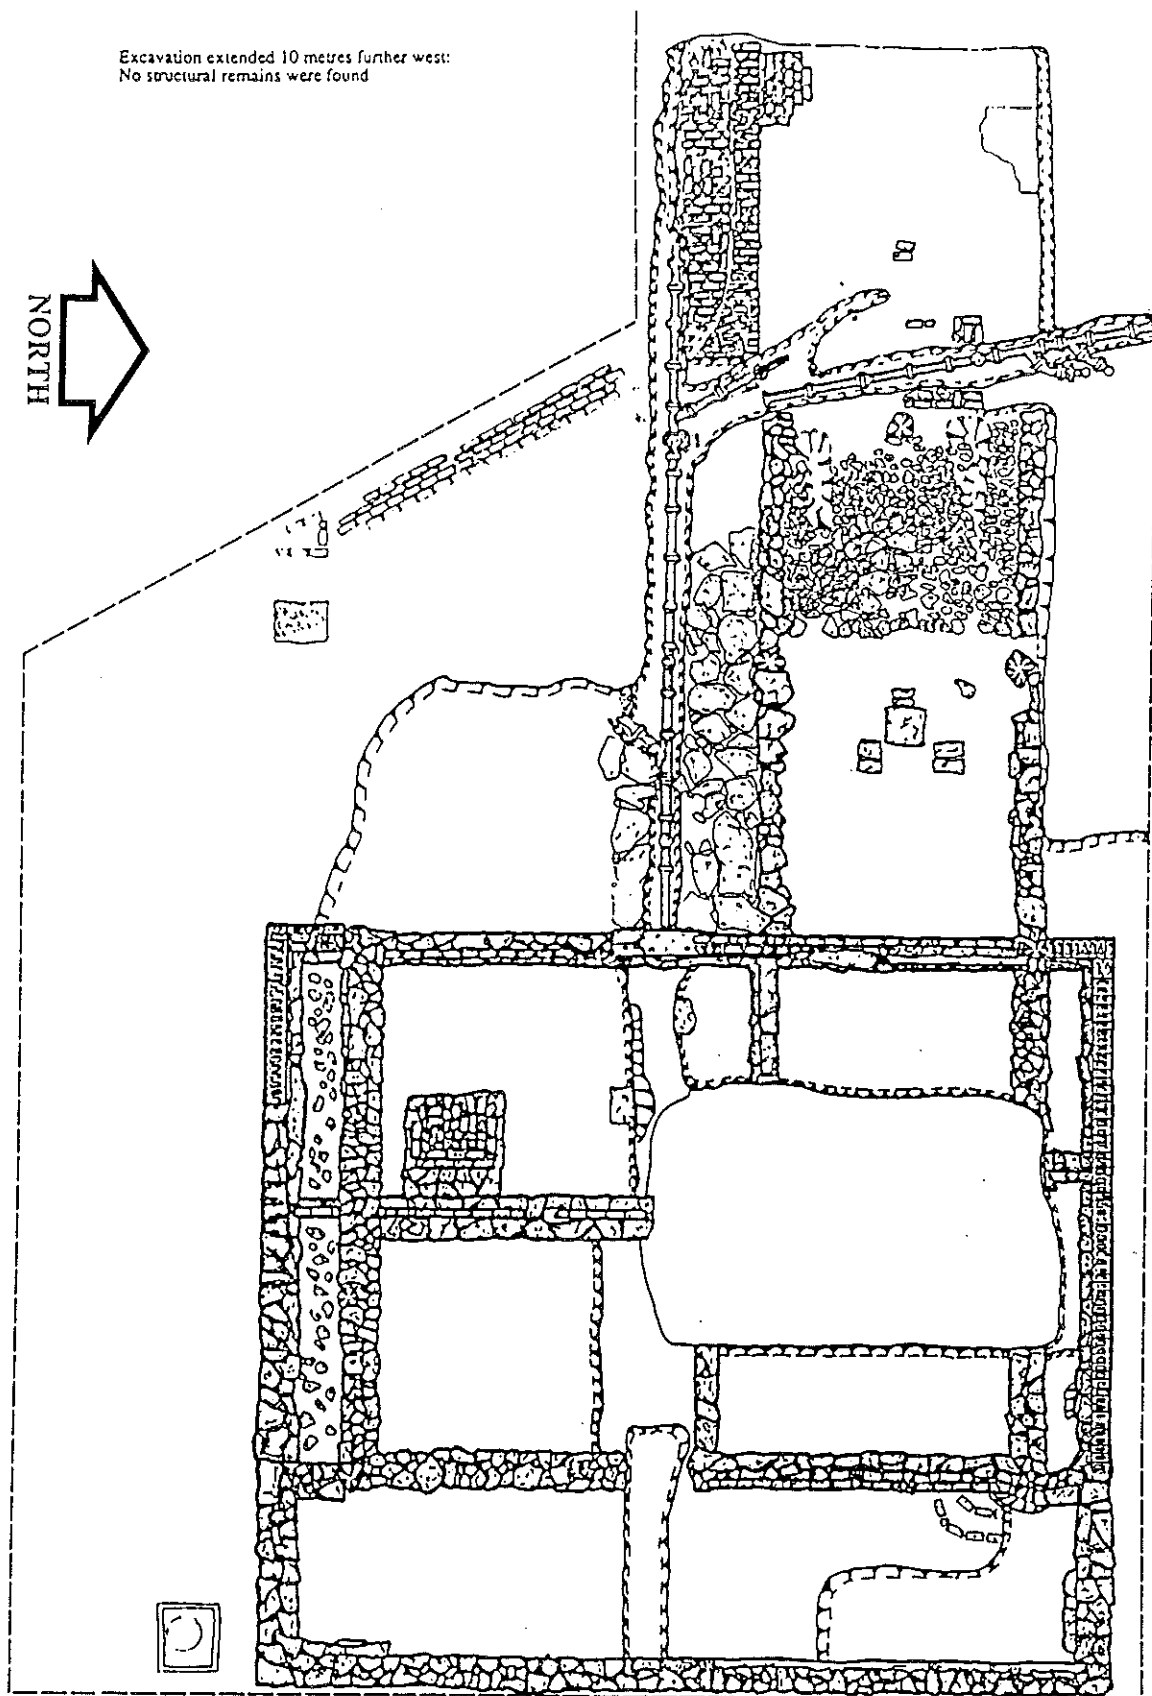
Figure 40

Plan of the excavated remains of the Victoria Hotel and the Stanley Arms Hotel showing the foundations of the buildings and the later lines of drain pipes cut across the site. The rectangular pit dug to install the petrol storage tank in the 1960s is visible in the centre of the northern part of the main building. Measured and drawn by Dana Mider and Andrew Wilson, detailed by Nicholas Arnold and Dana Mider from photographs by Andrew Wilson. Scale 1:100

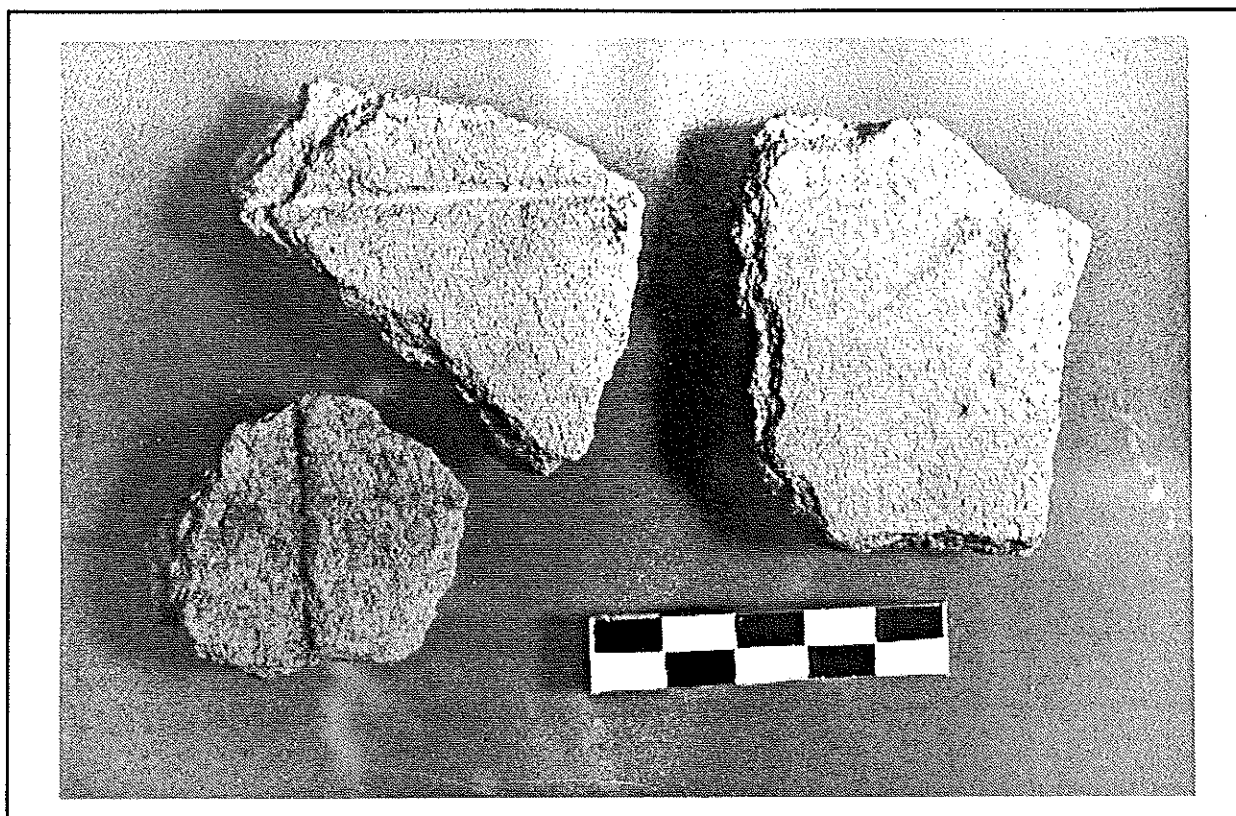
Figure 50
Scored render recovered from the demolition of the 1854 brick Stanley Arms building. The dark coloured render was scored to resemble stone. Photograph Number M56.18 by Andrew Wilson. Scale in 10mm divisions

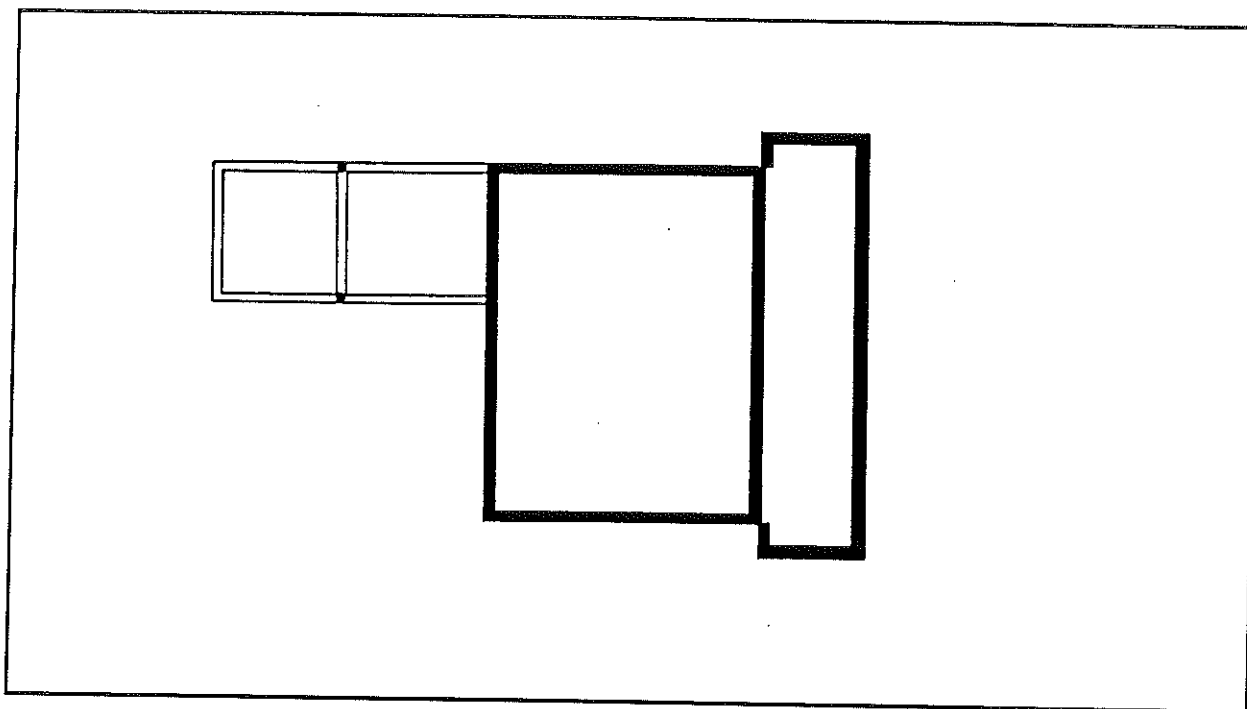
Figure 51

The fifth stage of construction was the addition of an extension to the east (that is the front) of the hotel using machine-made bricks on roughly dressed quarried bluestone foundations. This extended the building three metres to the east and one metre to the north and south, making it conform to the allotment boundaries laid out in the survey of Footscray in 1849. [See Figure 51]

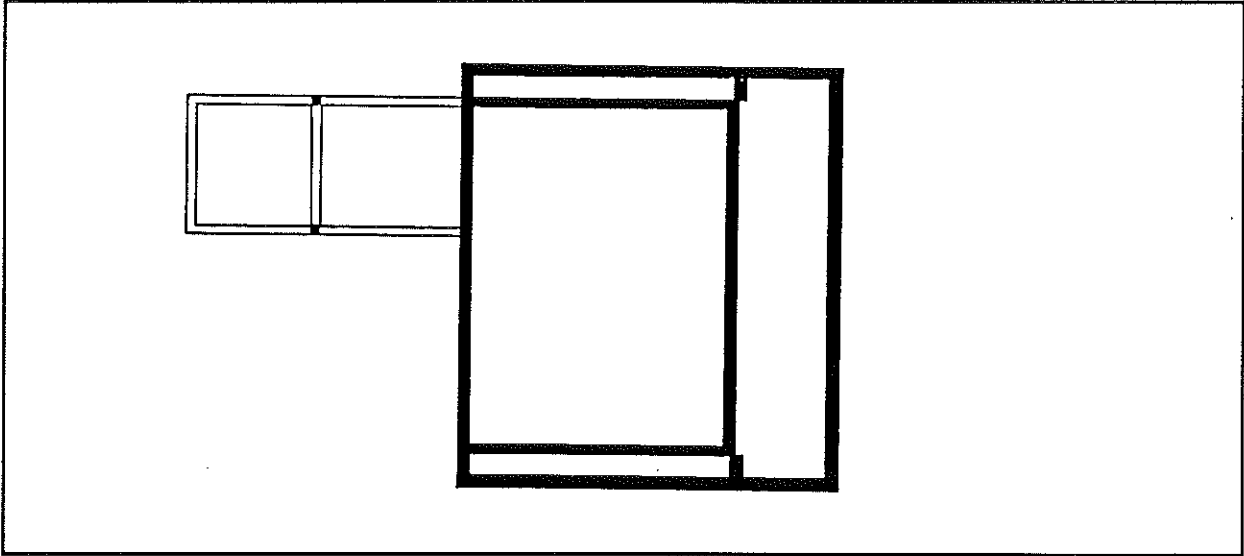
Figure 52

Schematic Plan of the sixth stage of construction on the Stanley Arms Hotel Site; showing the new side wall built to support a new two storey structure designed to enclose the 1854 building before its demolition. Scale 1:200

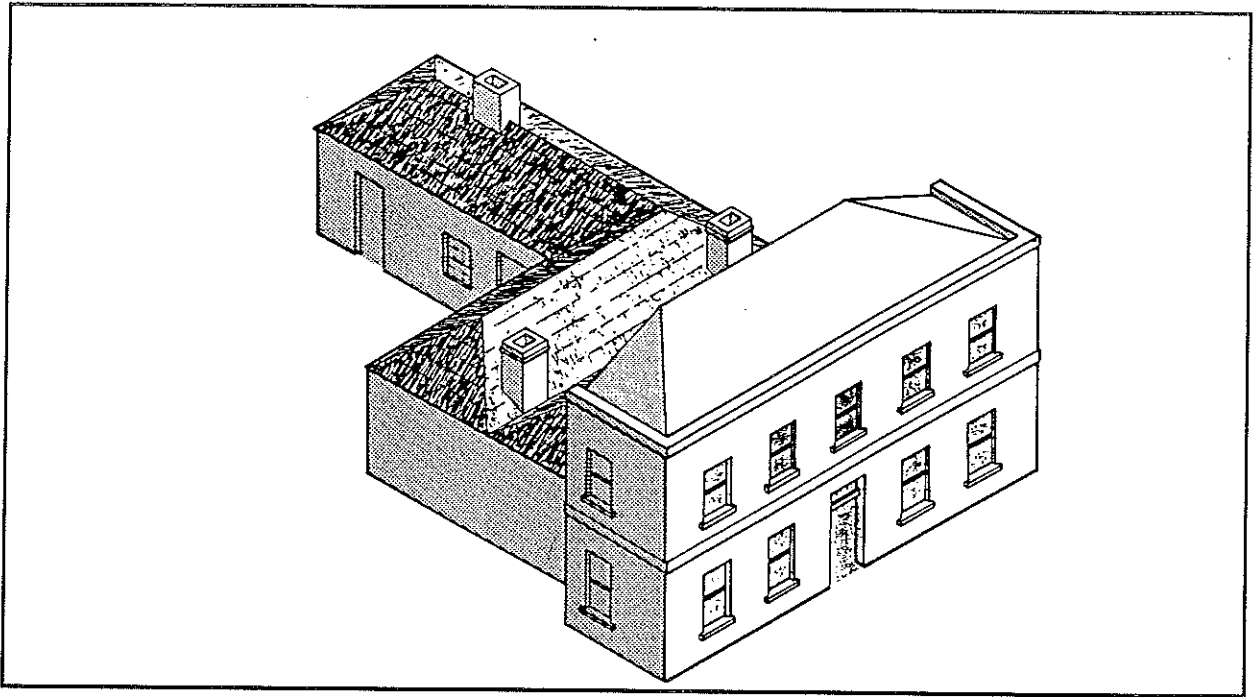
Figure 57

A speculative reconstruction drawing of the Stanley Arms Hotel in 1859, based on the excavated remains. The two storey eastern extension has now largely obscured the original building. The eastern extension, which was designed to conform to the 1848 property boundary, was the first part of a planned two stage building program. Isometric projection by Andrew Wilson. Scale 1:200

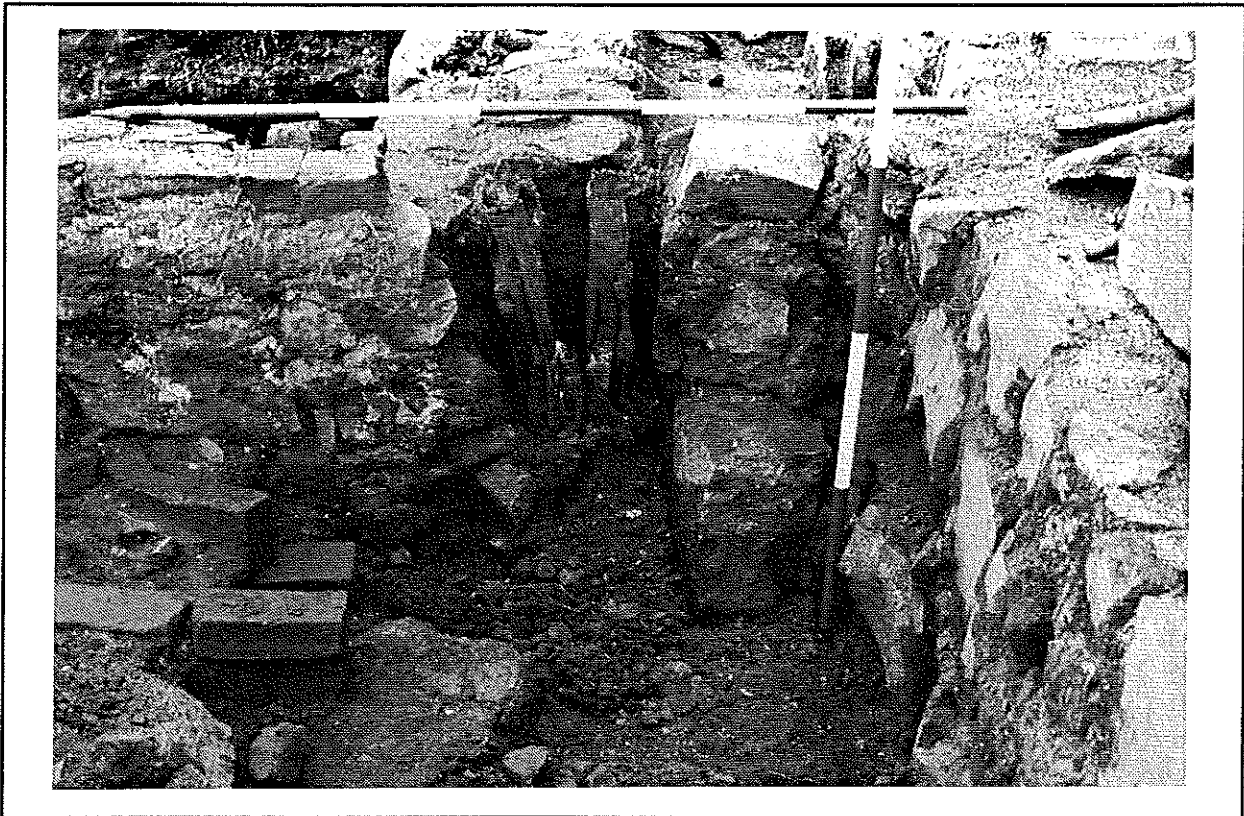
Figure 59

The post in the northeastern corner of the Victoria Hotel. The post was set in a hole 400mm deep and the stone plinth which formed the foundation of the building was built up around it to a height of 600mm. Photograph Number M49.27 by Andrew Wilson. Scale in 200mm divisions

The earliest deposit to reveal information about the European occupation of the Stanley Arms Site was the fill of the posthole in the northeastern corner of the original building.⁹⁴ [See Figure 59]

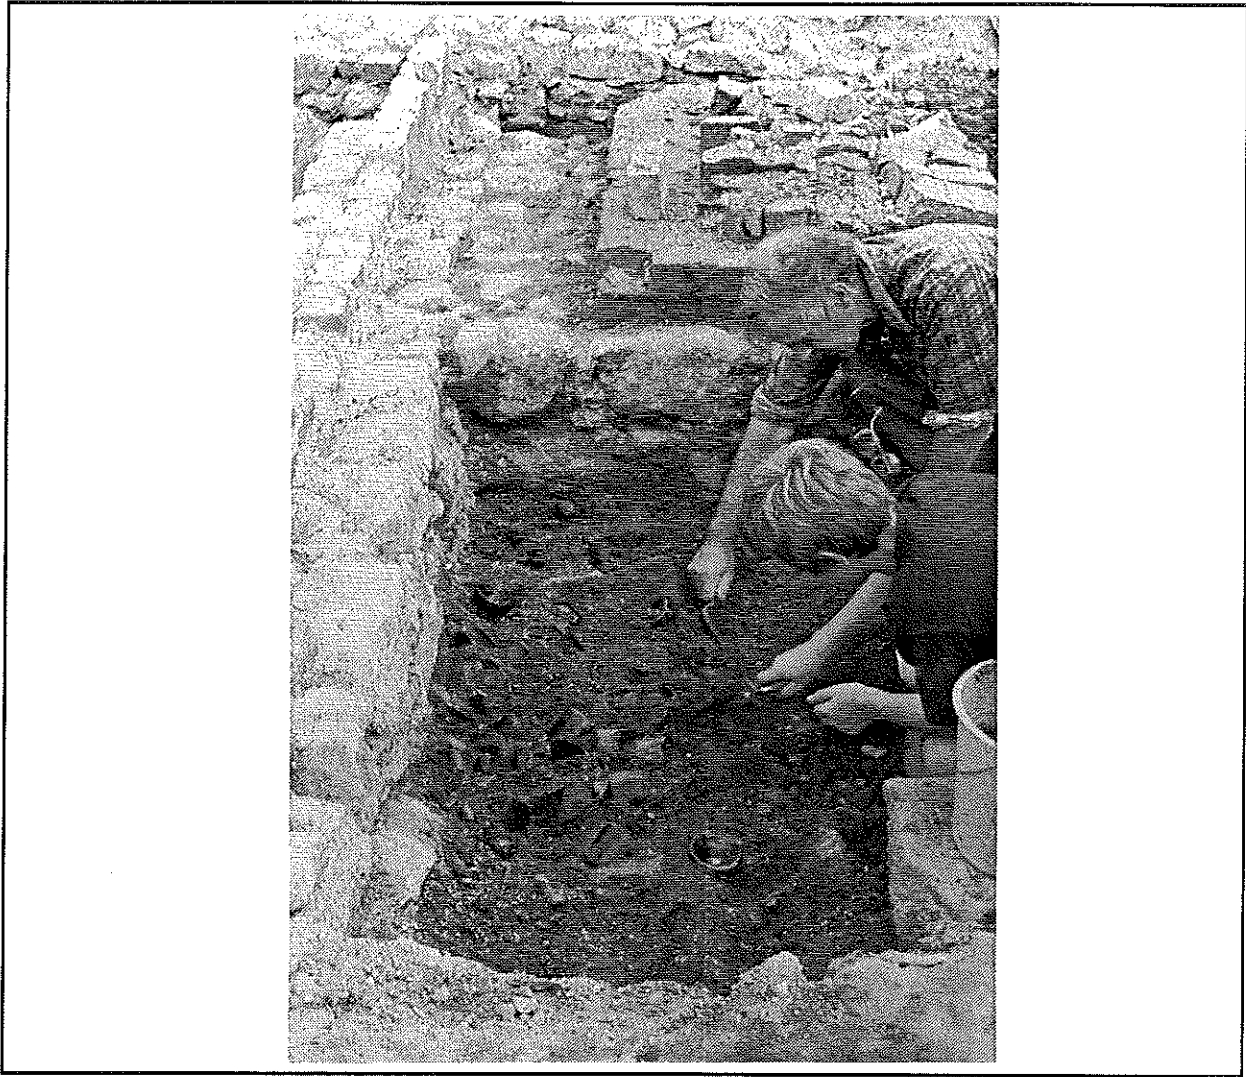
Figure 66

David Ellson Sr and David Ellson Jr excavating broken bottles from the deposits within the Victoria Hotel. The bottles are typical early nineteenth century 'black' glass bottles made to contain wine, beer and spirits. Photograph Number M44.15 by Andrew Wilson

The most striking feature of the deposits is the presence of the large amount of bottle glass in the underfloor areas. More than 46kg of bottle glass was recovered and a count of bottle lips and bases gives a minimum number of 104 bottles, although these represent fragmentary remains of a much larger number. [See Figure 66] It is clear that the bottles could not have fallen through the floorboards, however rough and primitive they might have been.

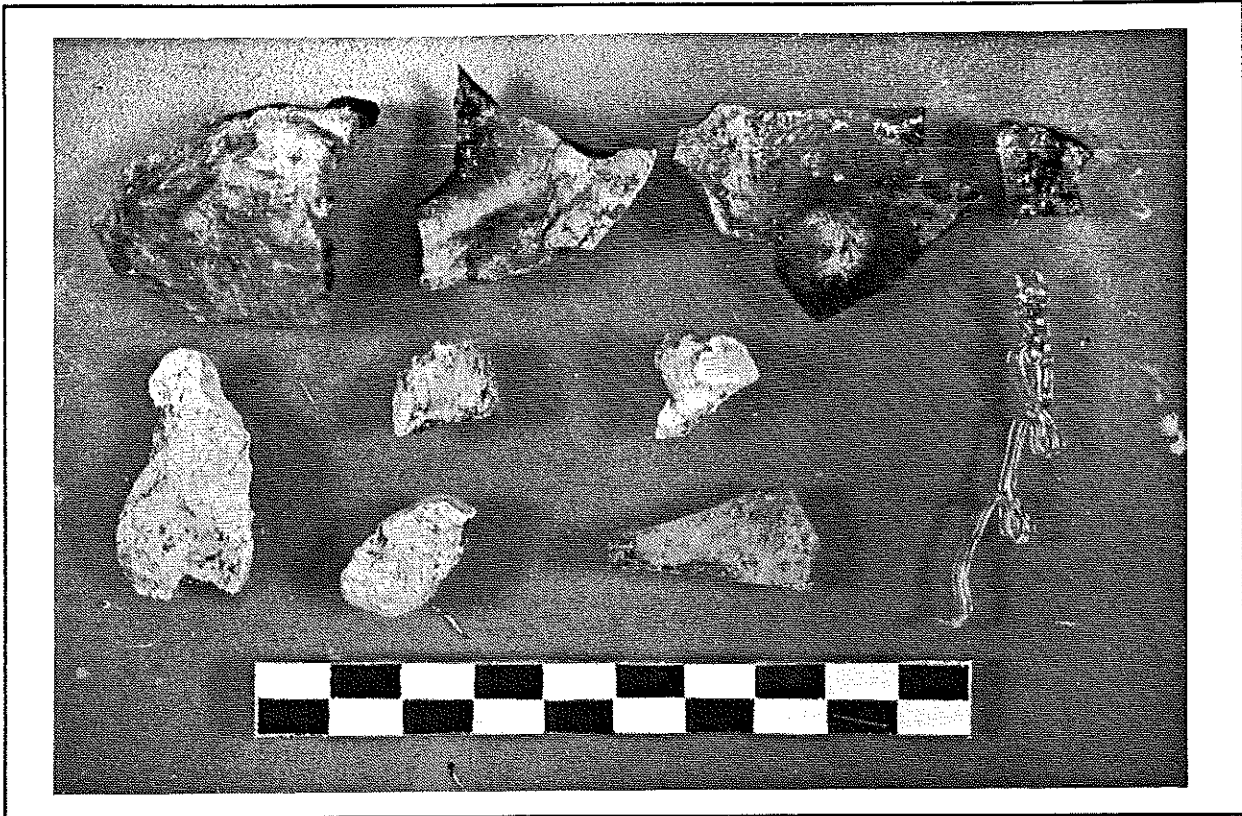
Figure 68

Examples of Melted and Burnt Glass from the fire of the early 1860s in the Stanley Arms Hotel. Photograph Number M52.22 by Dana Mider. Scale in 10mm divisions

The most important aspect of the artefacts from this deposit is not the amount of material but the range of domestic objects present. Unlike almost all the other deposits on the site the artefacts in this deposit were not discarded or lost, they were destroyed by the fire. [See Figure 68] This gives us the opportunity to see, however imperfectly, what kind of objects were present in the room on an ordinary day in the early 1860s.

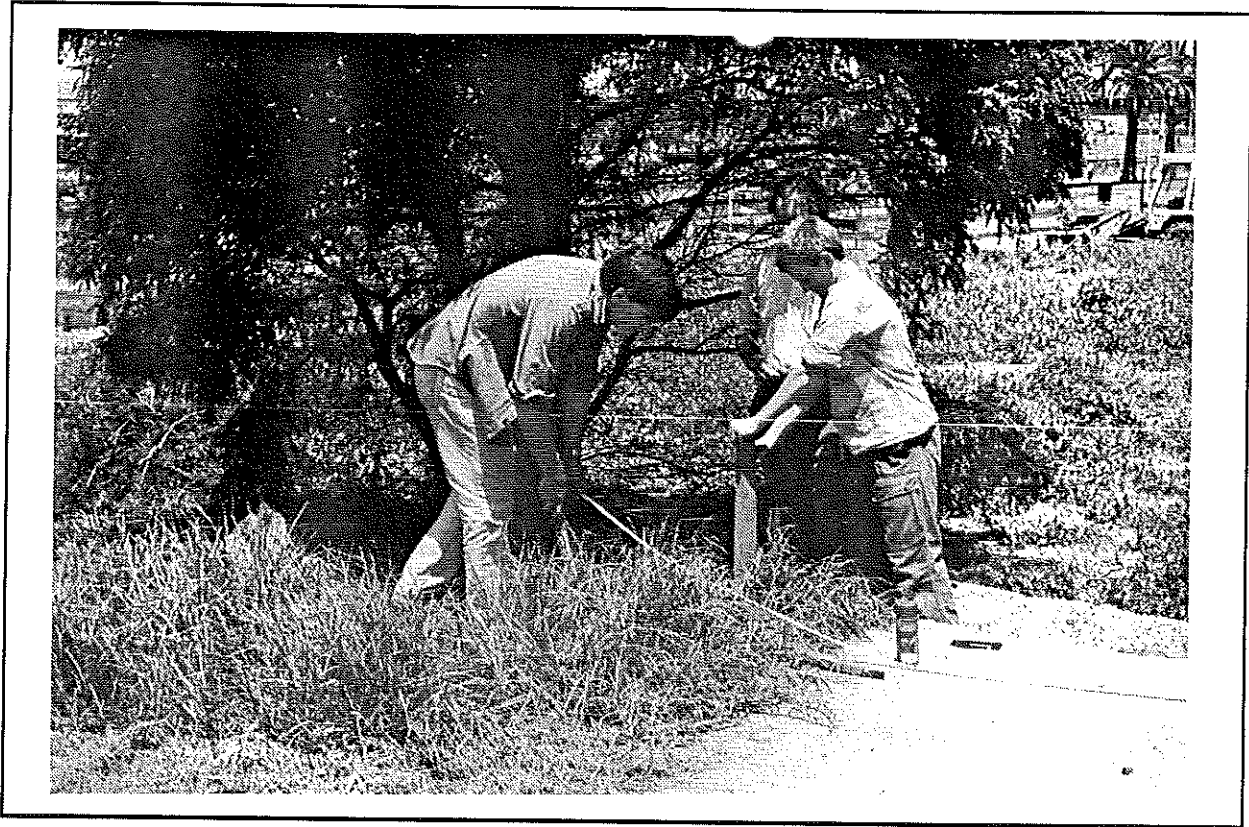
Figure 76

Roger Cummins, David Ellson Snr and David Ellson Jnr documenting the precise location of the Pickett Cottages Site by measuring from survey points. Photograph Number M01.34 by Richard Moline

The location of each of the three sites to be excavated was plotted from historic plans. A notional one square metre grid was then located over the site from survey points. [See Figure 76] Individual metre squares within the grid, called Quadrats, were identified using an alpha-numeric code. The notional grid was not used to define the excavated area but enabled one or more square metres of large deposits to be sampled and their artefacts to be kept separately.¹²³
